HISTORIC STRUCTURE REPORT

FORT MATANZAS NATIONAL MONUMENT
ST. JOHN'S COUNTY, FLORIDA

THE FORT MATANZAS STABILIZATION TEAM

DENVER SERVICE CENTER
SOUTHEAST/SOUTHWEST TEAM
HISTORIC PRESERVATION BRANCH
NATIONAL PARK SERVICE
UNITED STATES DEPARTMENT OF THE INTERIOR
DENVER, COLORADO

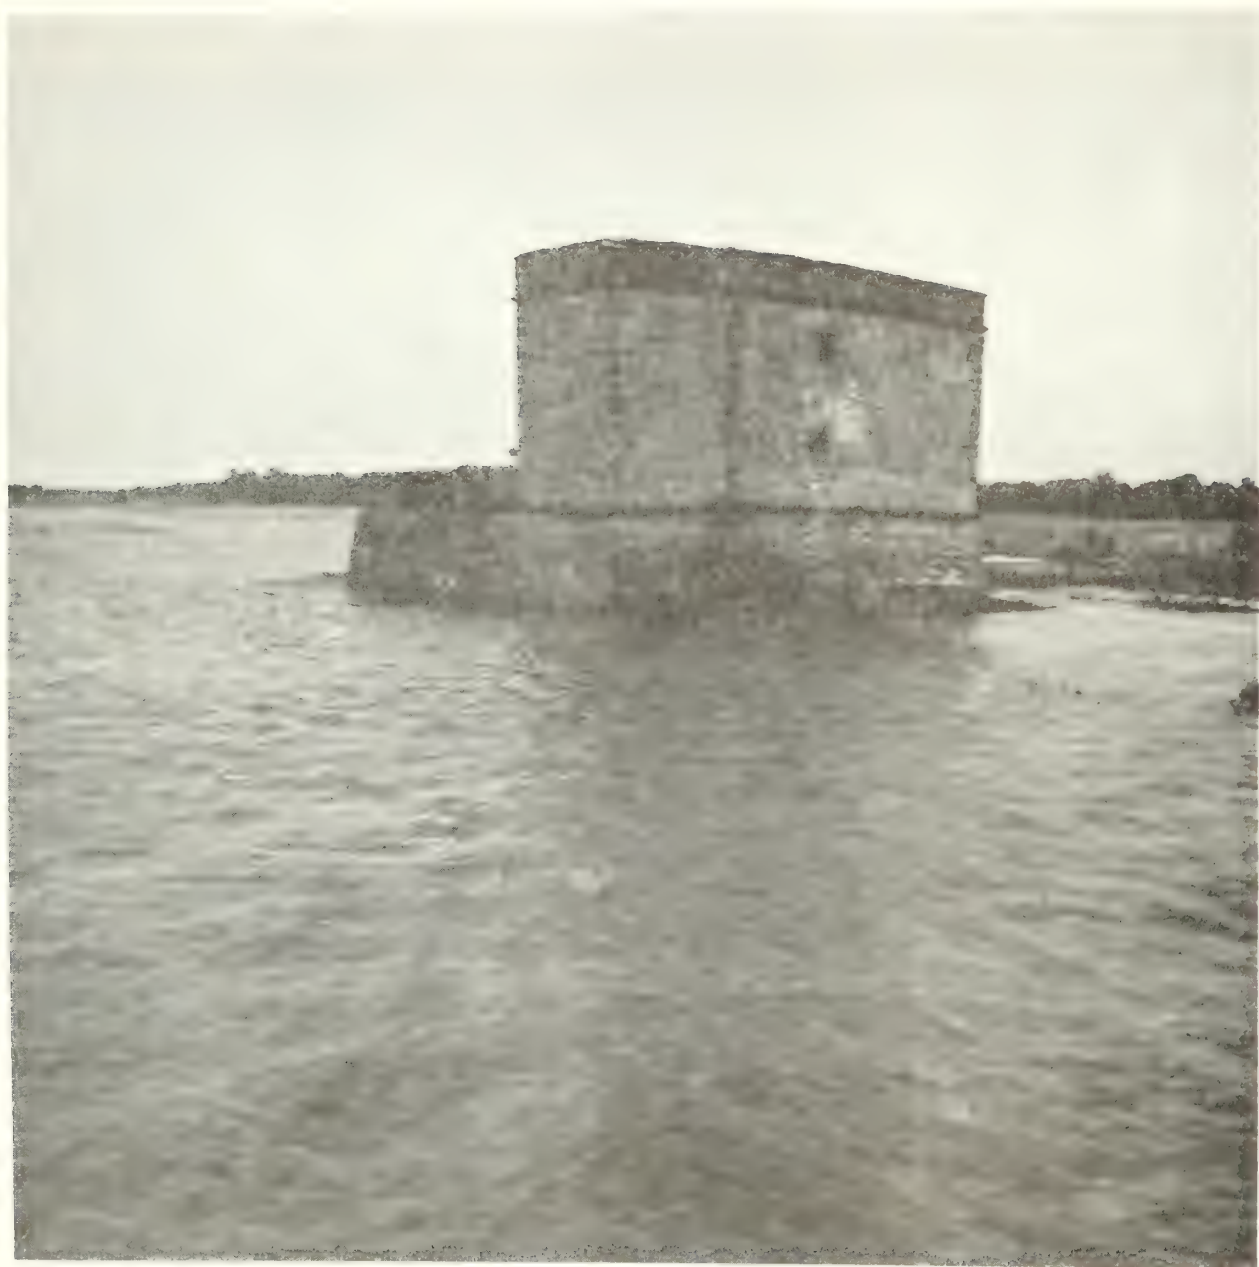
Illustration 17

Presently, even though the site is still subjected to abnormally high tides which rise to the base of the fort at least once each year (Illus. 17) various shore protection projects have partially stabilized the land in the vicinity of the fort. In some instances these measures, although incremental, have performed very effectively. However, they have created an undesirable visual impact on the historic scene, and more important have not dealt with the total erosion problem.

Fort Matanzas During Storm High Tide, November 3, 1978.

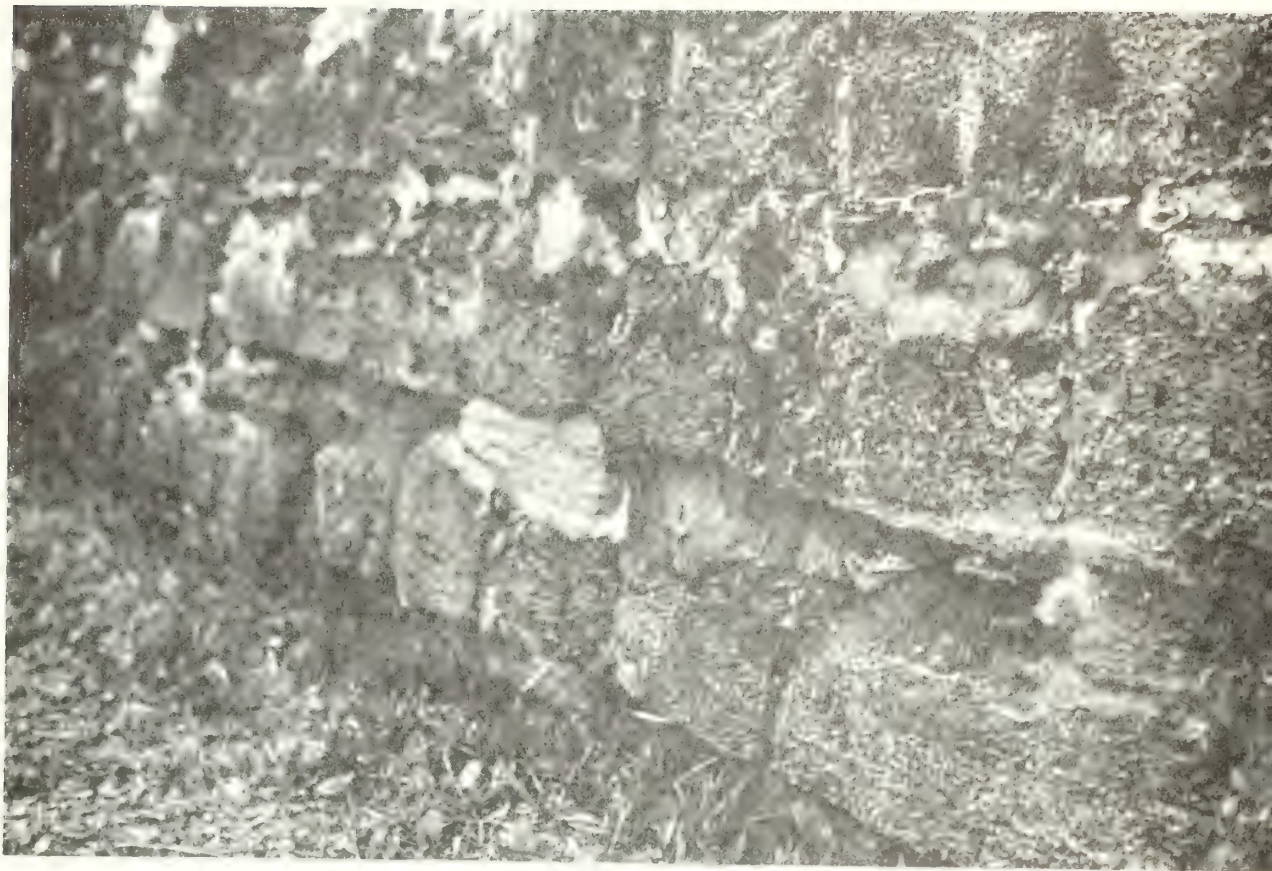
Illustration 20

Detail of East Scarp Erosion

Weathering due to exposure to wave actions.

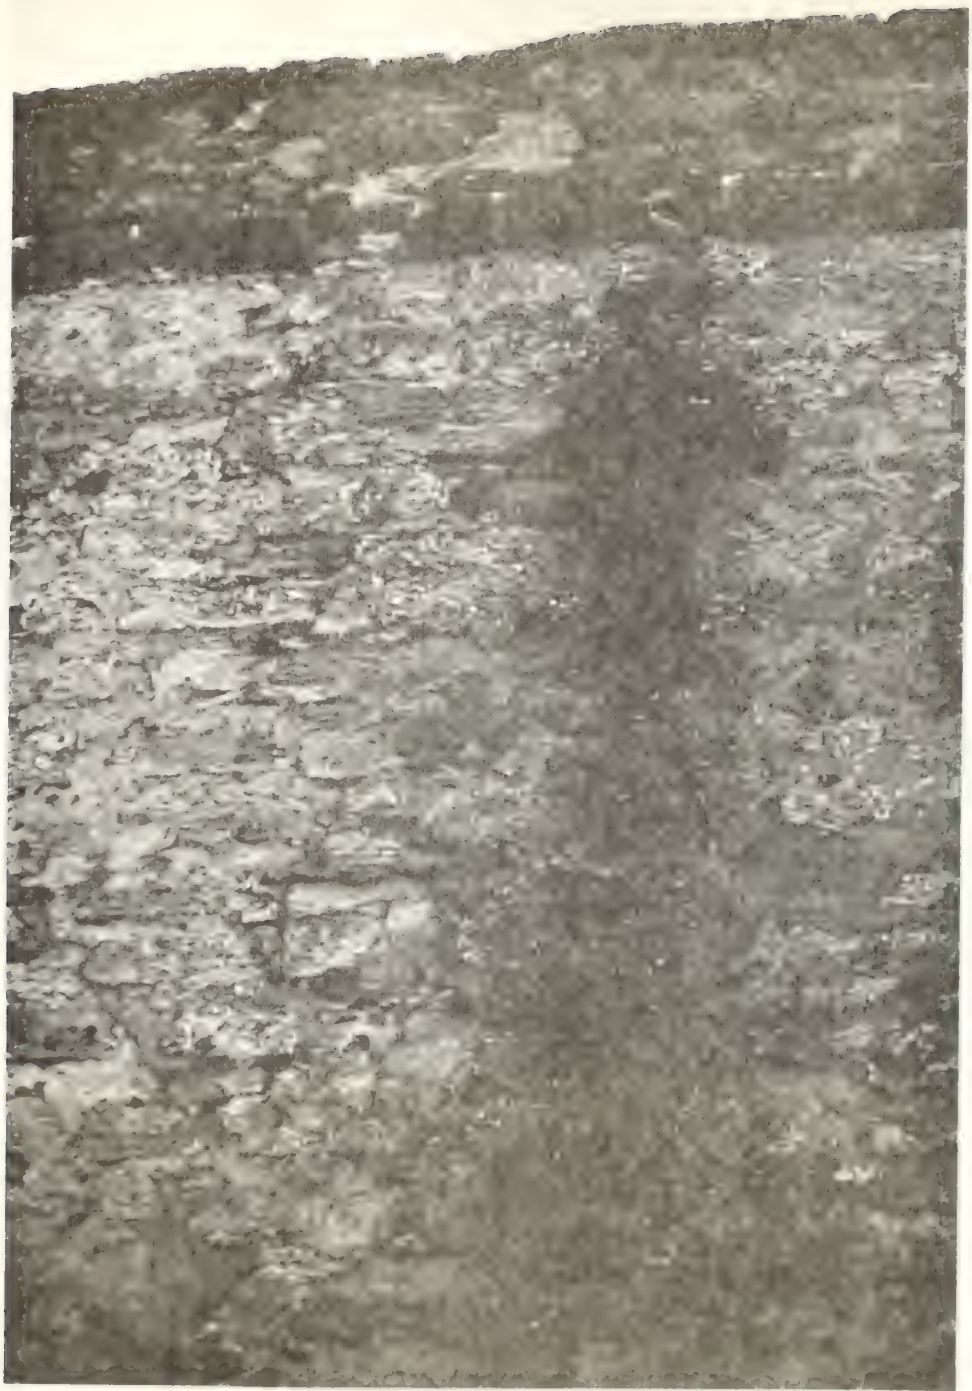
Illustration 21

Detail of North Face Under Non-Historic Scupper

Vegetation growth on the fabric results from the water run off from the roof. Historically, water was drained through a single scupper and wooden downspout on the south face to the cistern. Note missing cordon stone to left of scupper.

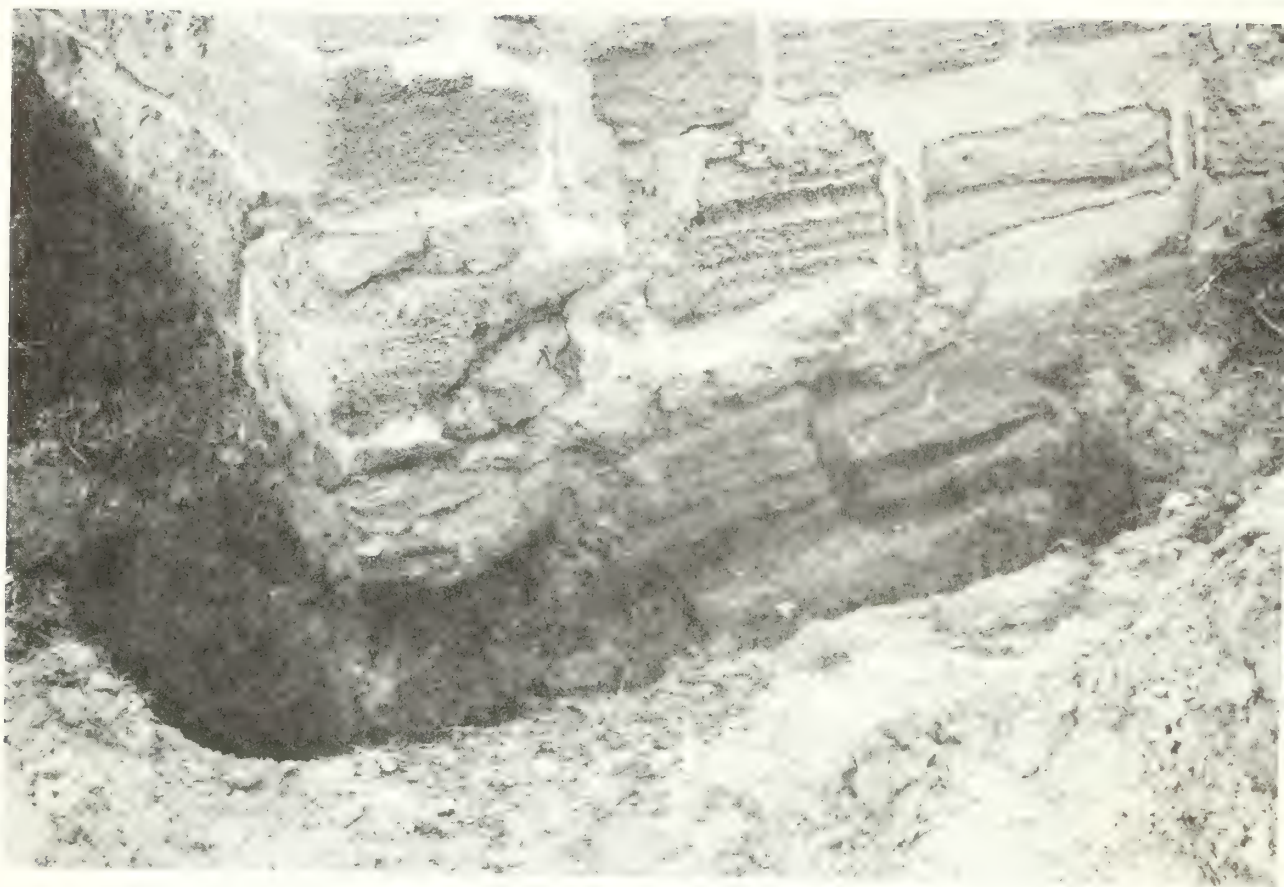
Illustration 22

Detail of Subgrade Scarp at Southwest Corner (South Salient)

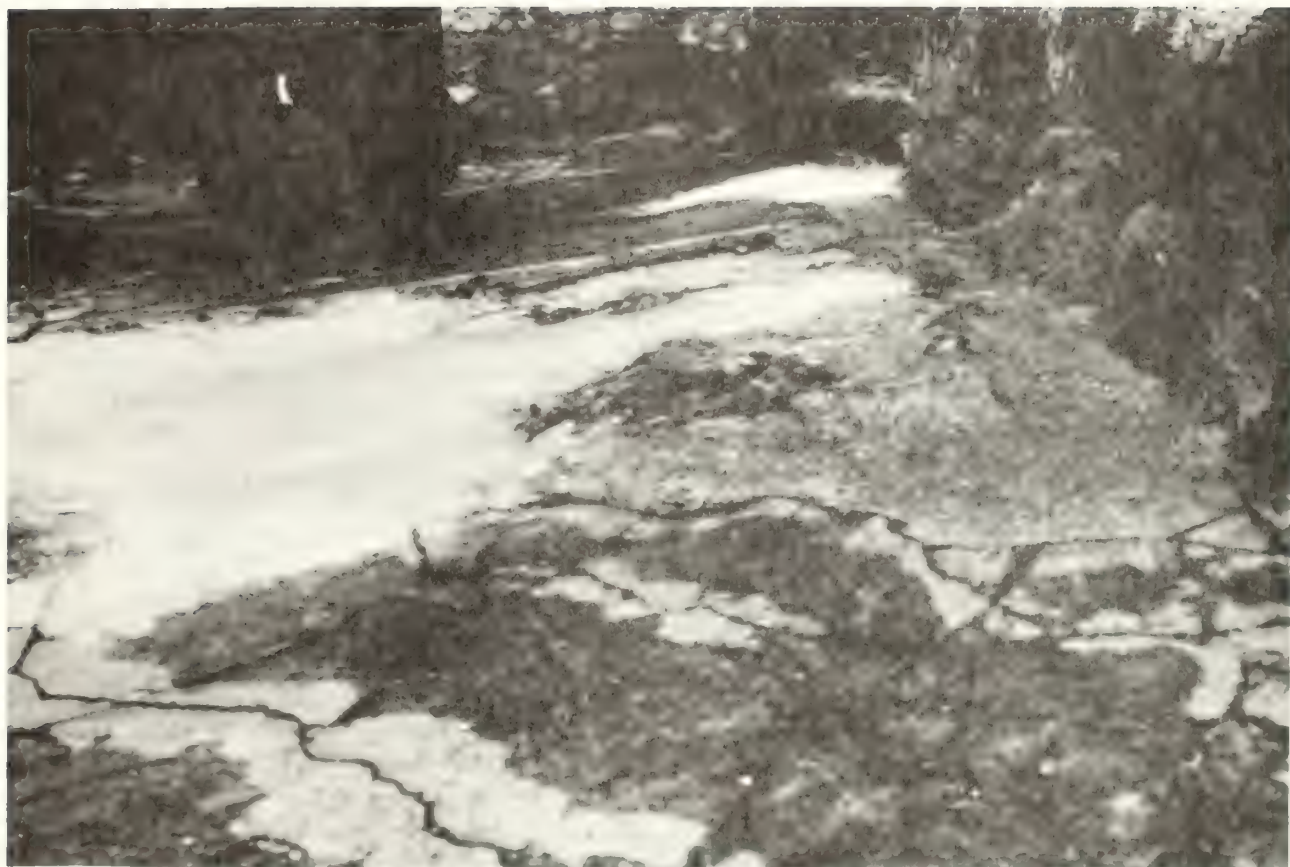
Illustration 23

Detail of Terreplein

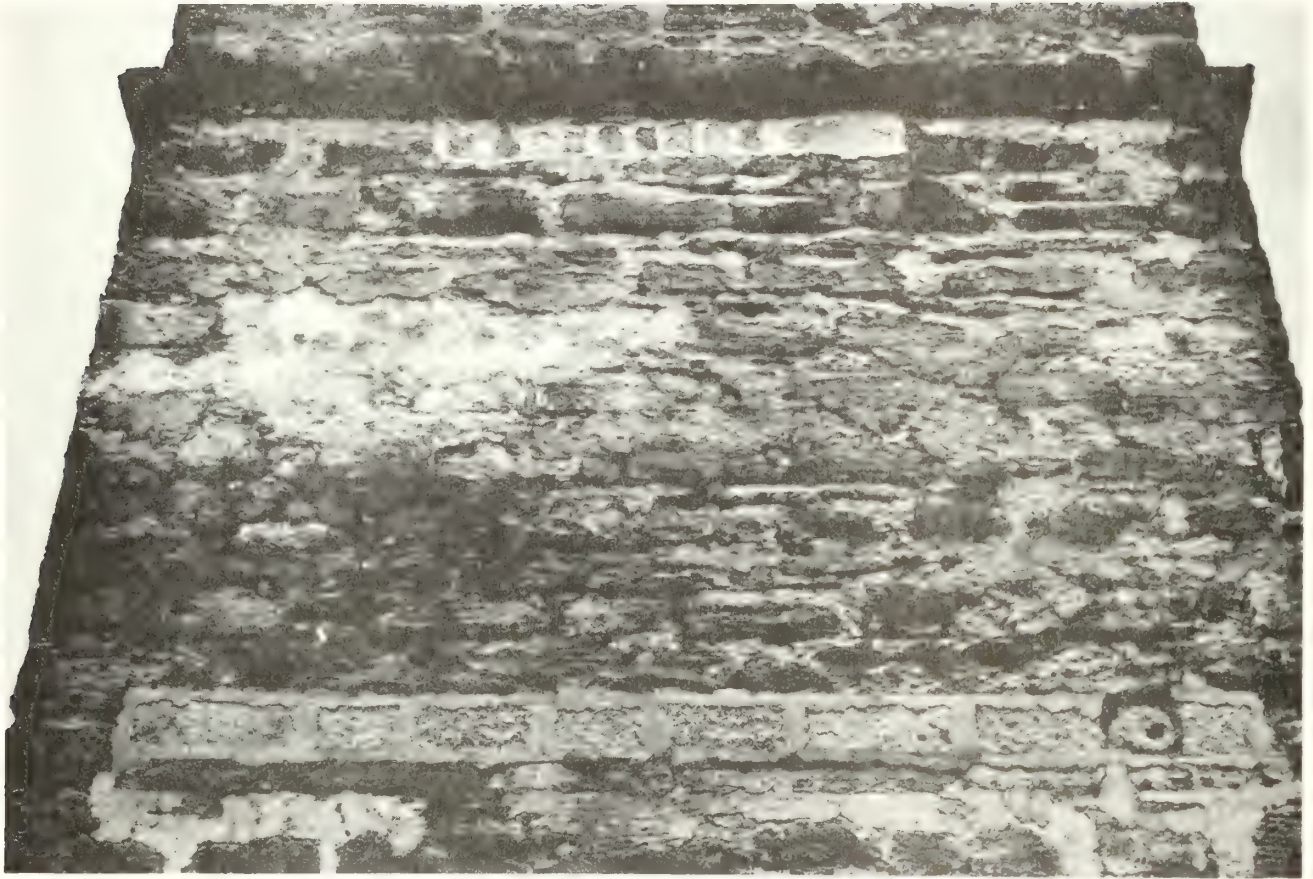
Illustration 24

Detail of West Réduit Face

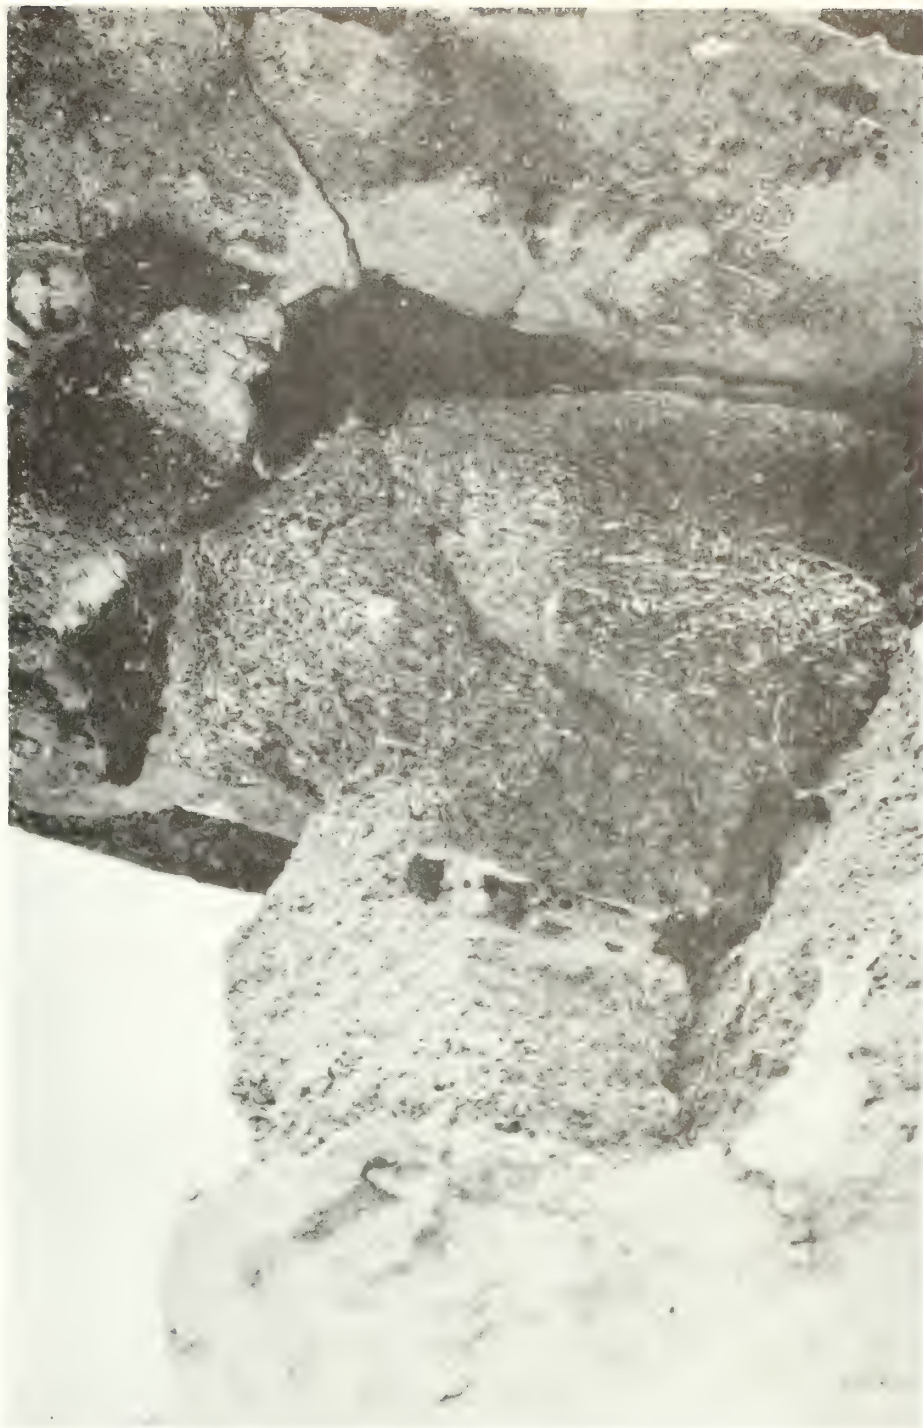
Illustration 26

Detail of Sentry Box Base

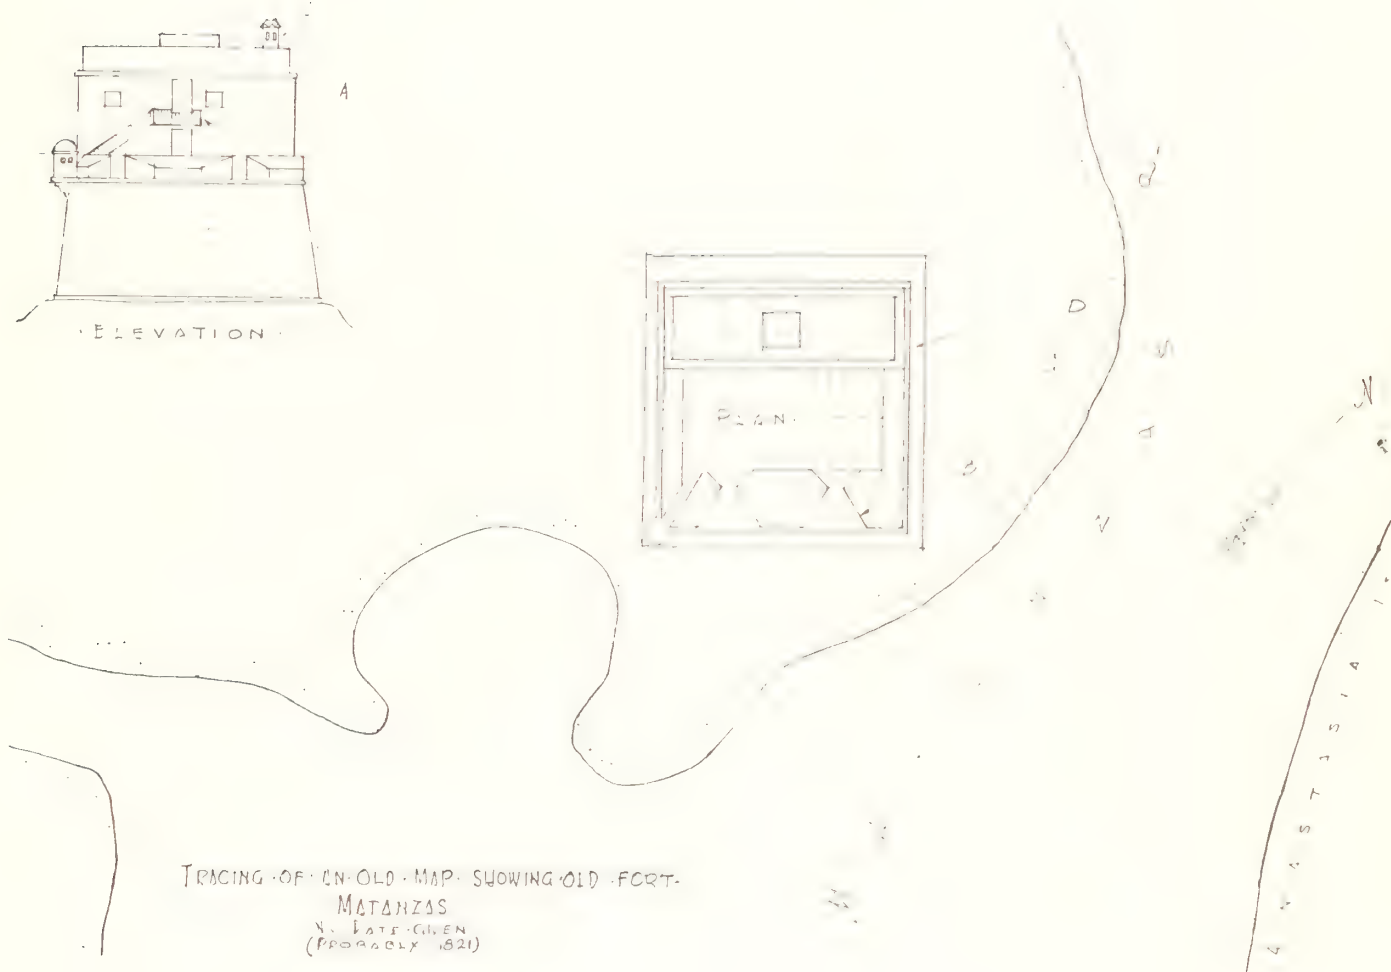
Illustration D-2

Ramón de la Cruz, N^o 5, Torre de Matanzas con su barra, June 4,
1821, National Archives

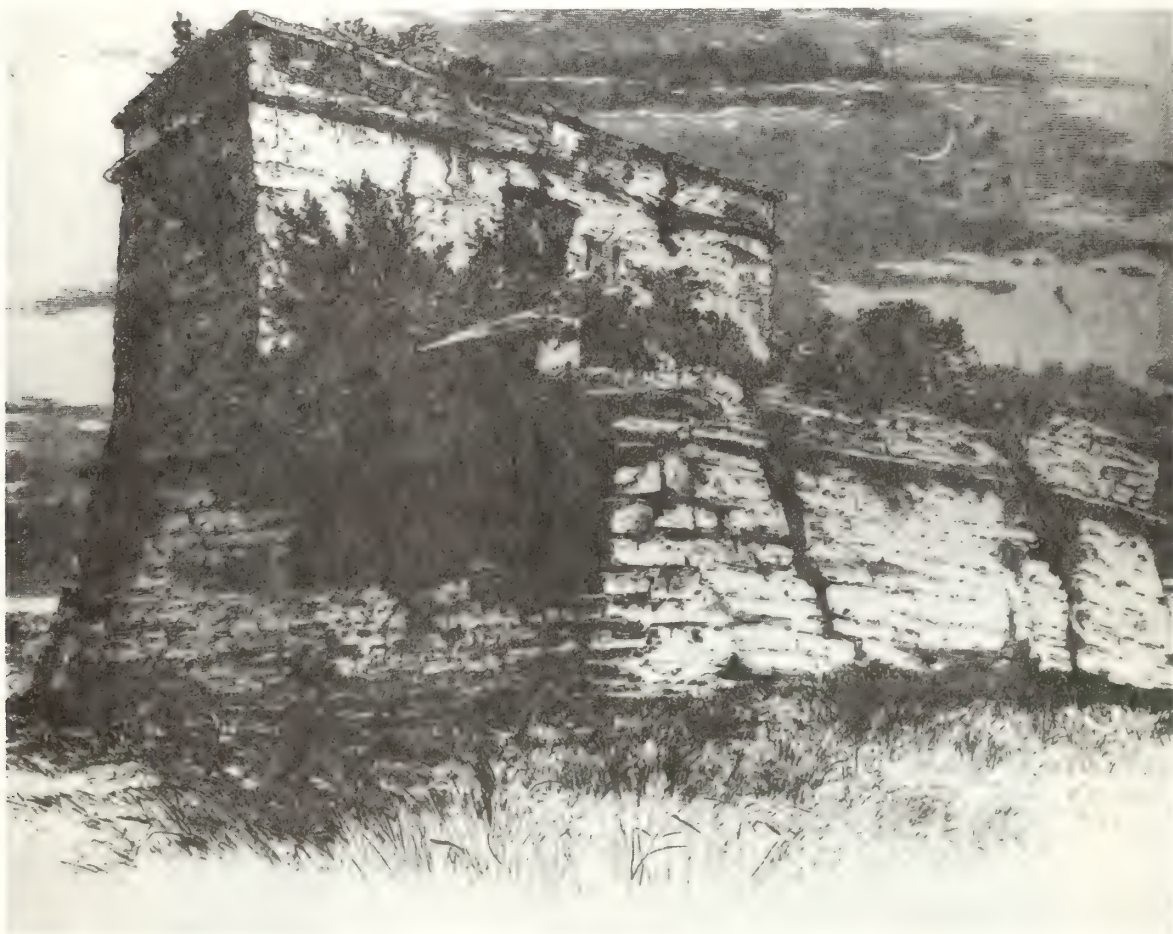
Illustration D-3

Fort Matanzas published in Picturesque America, 1872, (Photo M-42)

Note missing sentry box and south terreplein parapet at height lower than east and west parapets.

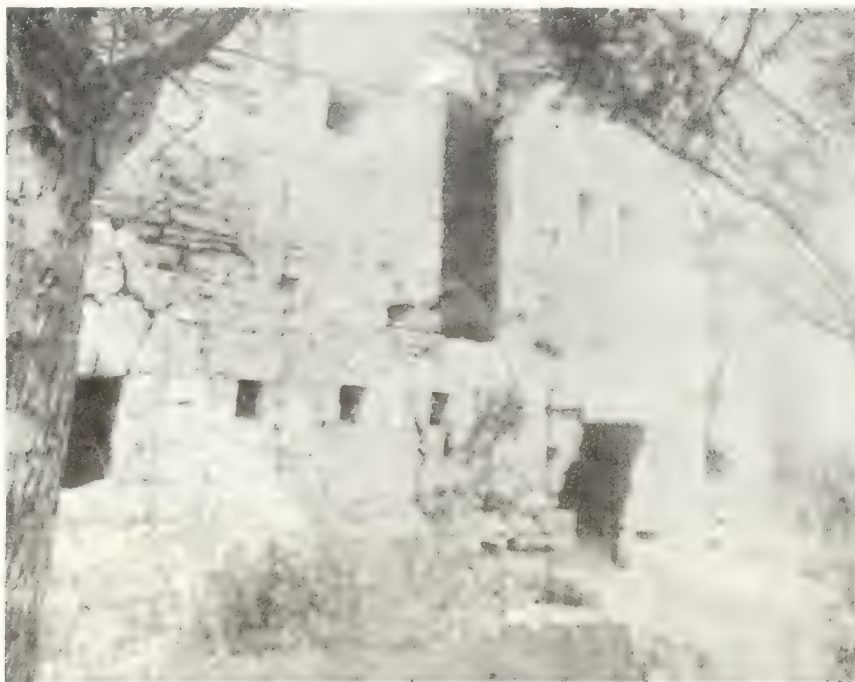
Illustration D-6

View of Terreplein and South Face of Tower, circa. 1914, (Photo M-168)

Note faint outline of a fourth loophole to the right of the three clearly visible.

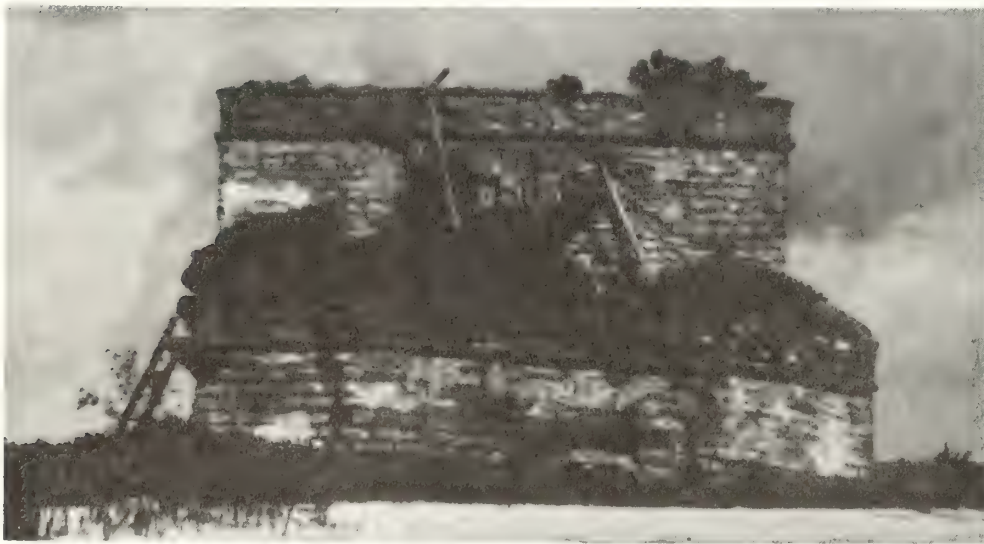
Illustration D-9

View of Fort Matanzas, 1916, (Photo M-70)

Taken after tower stabilization but prior to vegetation removal.
Note construction bracing yet to be removed.

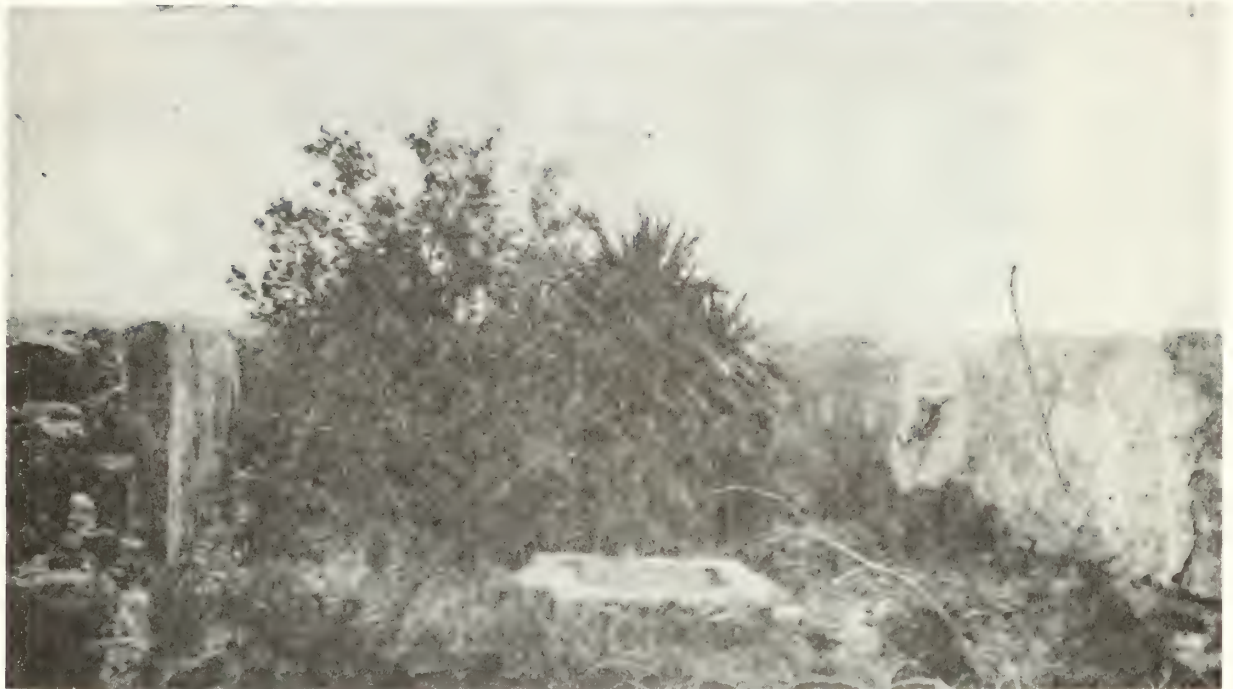
Illustration D-10

View of Tower Deck, 1923, National Archives

The condition of Fort Matanzas was documented by War Department personnel in April 1923. In this view we can see the irregular masonry of the 1916 repair to the south parapet (left). Much vegetation is still present. The scuttle curb wall is intact and like parapet walls, plastered. It also appears to have a special shape along its north and south edges--perhaps to accommodate the once existing hatch or hatch "house."

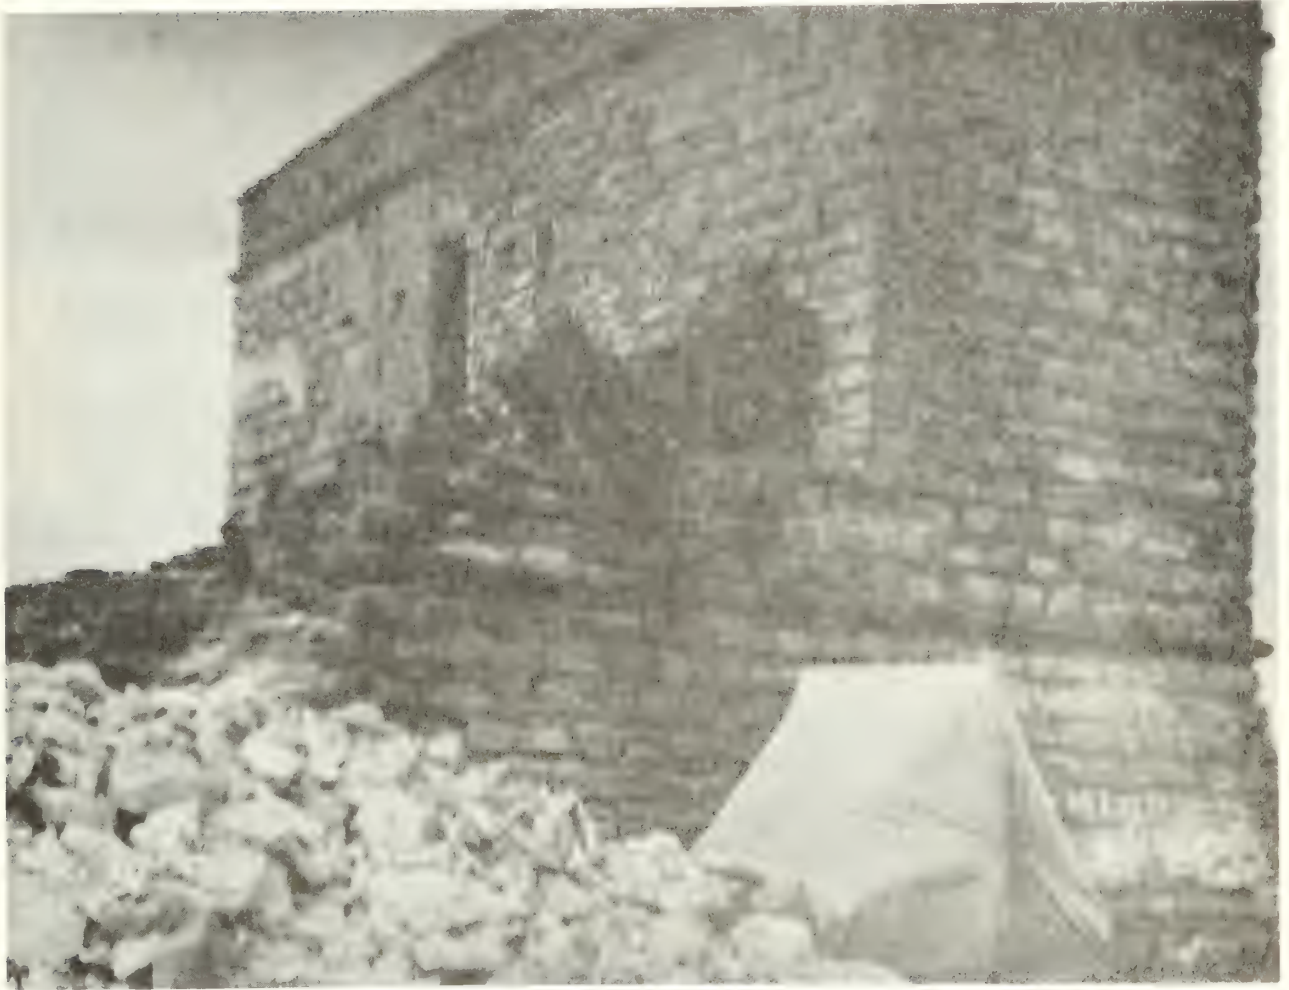
Illustration D-13

Dismantled East Scarp During 1924 Reconstruction (Photo M-76)

Notice tie rod end plates near tower cordon on east face as placed in 1916 preservation project. Also, notice iron cannon lying on terreplein as reported as early as 1885 by Scriven.

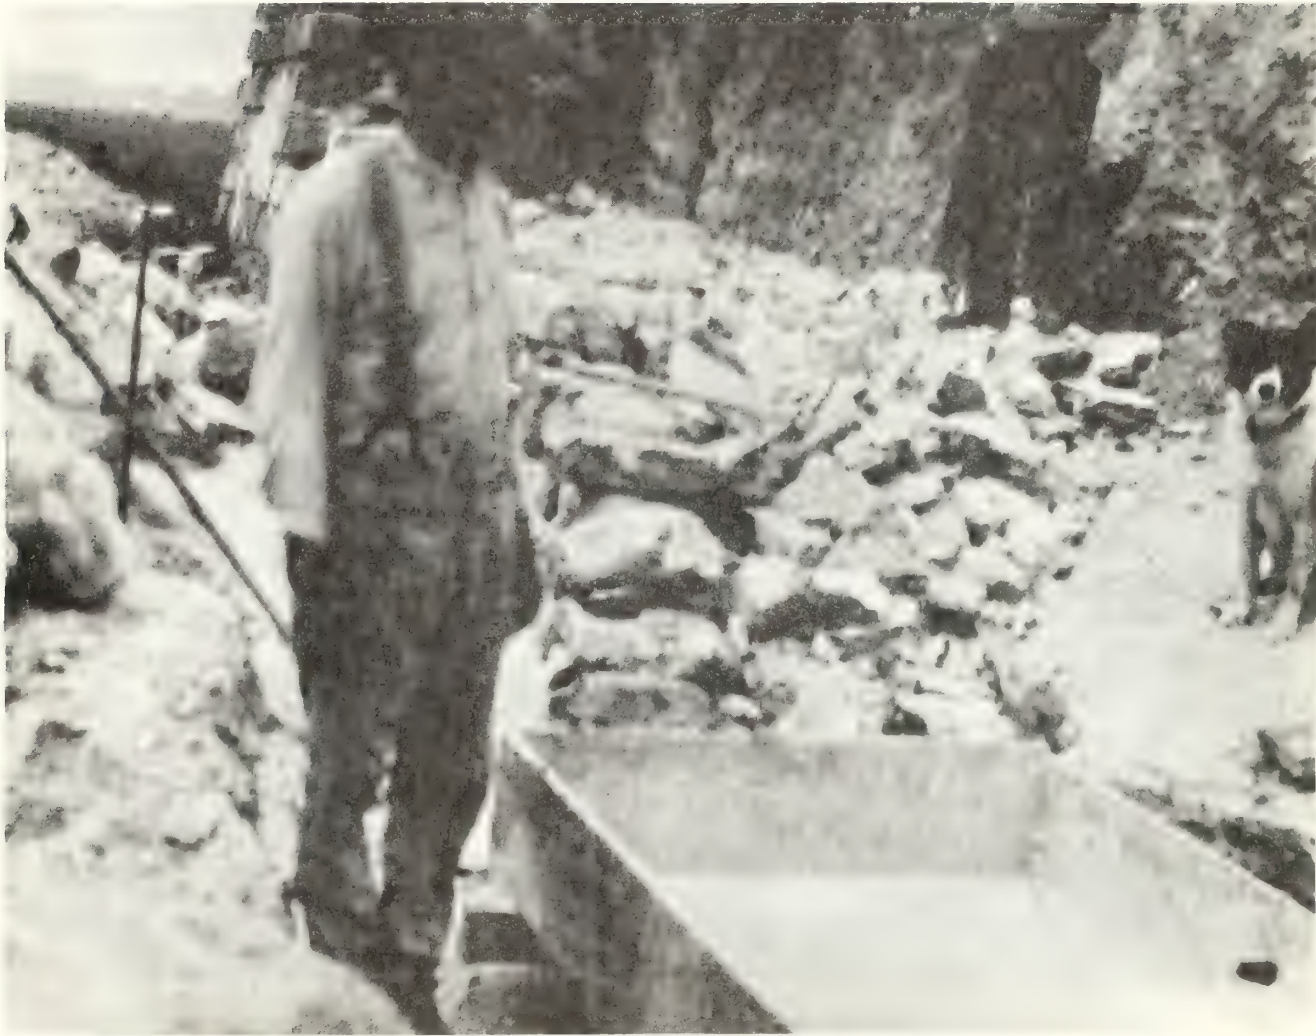
Illustration D-14

Dismantled South Scarp During 1924 Reconstruction (Photo M-76)

Contractor Bud Deyo is pictured here at the foot of the fort. It is interesting that the marsh mud fill of the base is dry enough to have cracked along with the shear failure of the south salient. It appears that the scarp wall is mostly rubble fill with cut stones forming the exterior face.

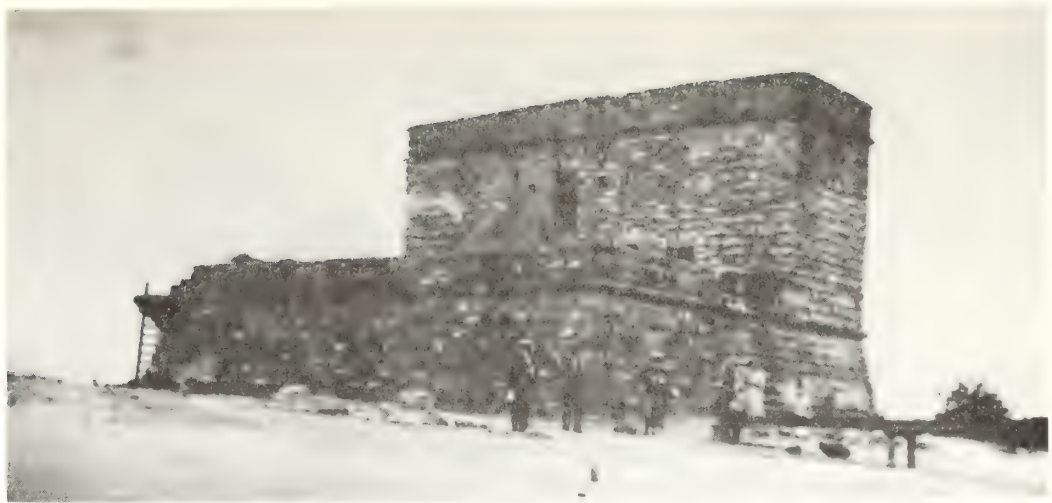
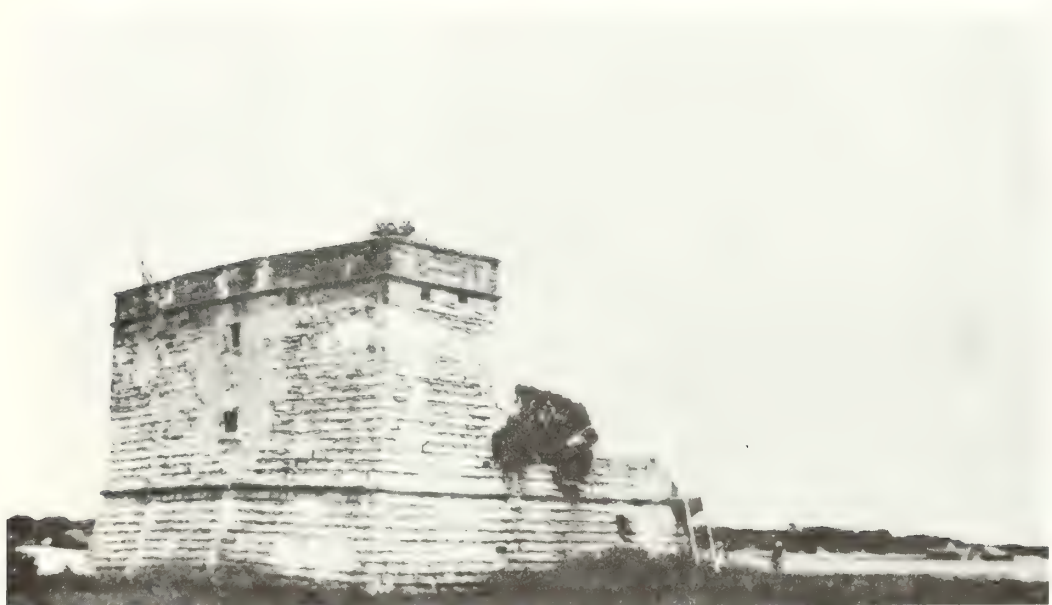
Illustrations D-16 and D-17

Fort After 1924 Reconstruction, National Archives

These views illustrate the preservation work accomplished by Bud Deyo in 1916 and 1924. The tower has been reassembled and tie rods employed to hold it together; the east salient rebuilt and terreplein parapets reconstructed. However, the east parapet should have been at least one course of stone higher than the south and should have included a second embrasure. Visitor access, at this date, is provided by a ladder to the sentry box base. An iron cannon can be seen at the east embrasure.

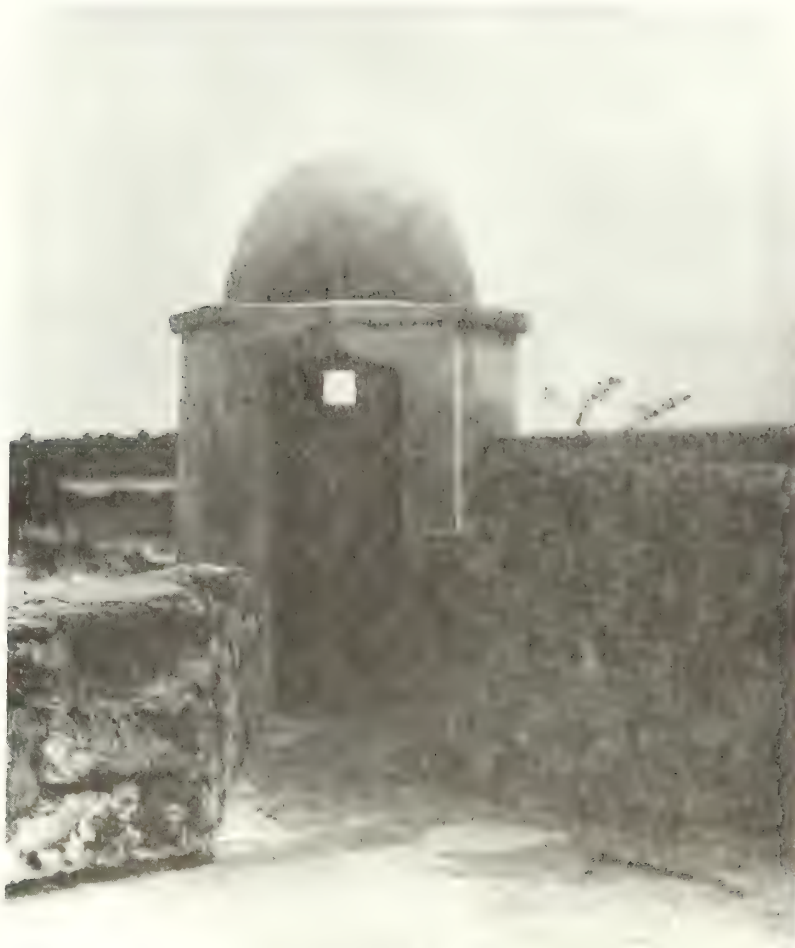
Illustration D-18

View of 1926 Reconstructed Sentry Box from Terreplein

This reconstruction used brick and coquina-concrete to produce an appearance which was quickly judged inappropriate.

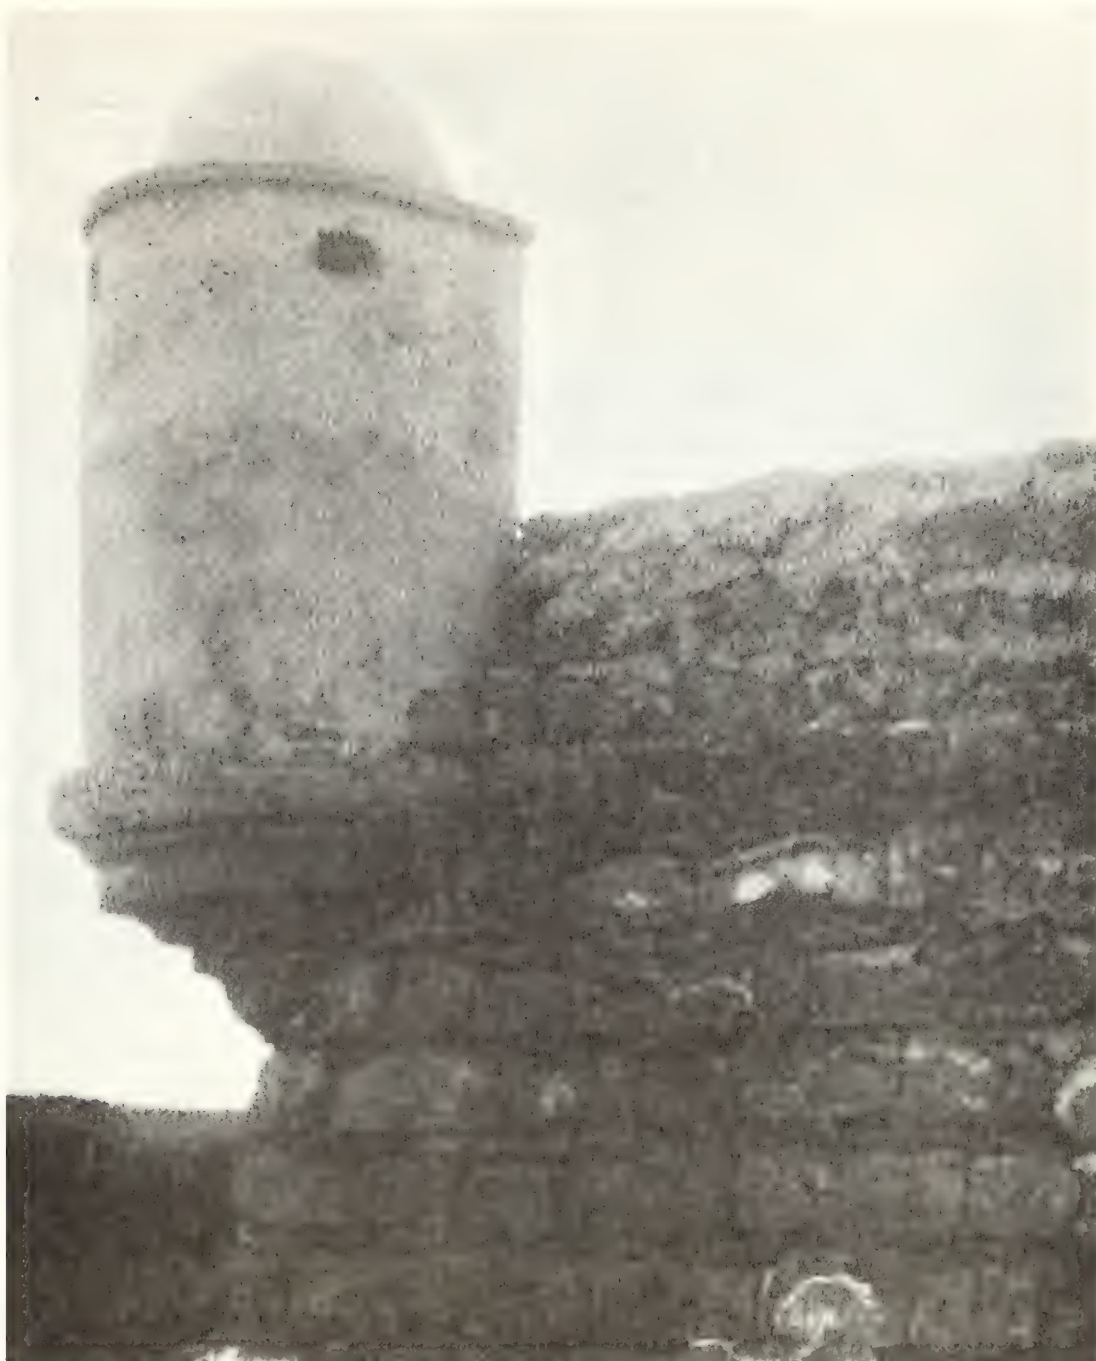
Illustration D-19

View of 1926 Reconstructed Sentry Box, Exterior View, August 1929,
(Photo M-14)

In this documentation of the first reconstructed sentry box in August 1926, we are offered a detailed view of the historic masonry coursing employed by the Spanish. This portion of the south scarp was not disturbed by Deyo.

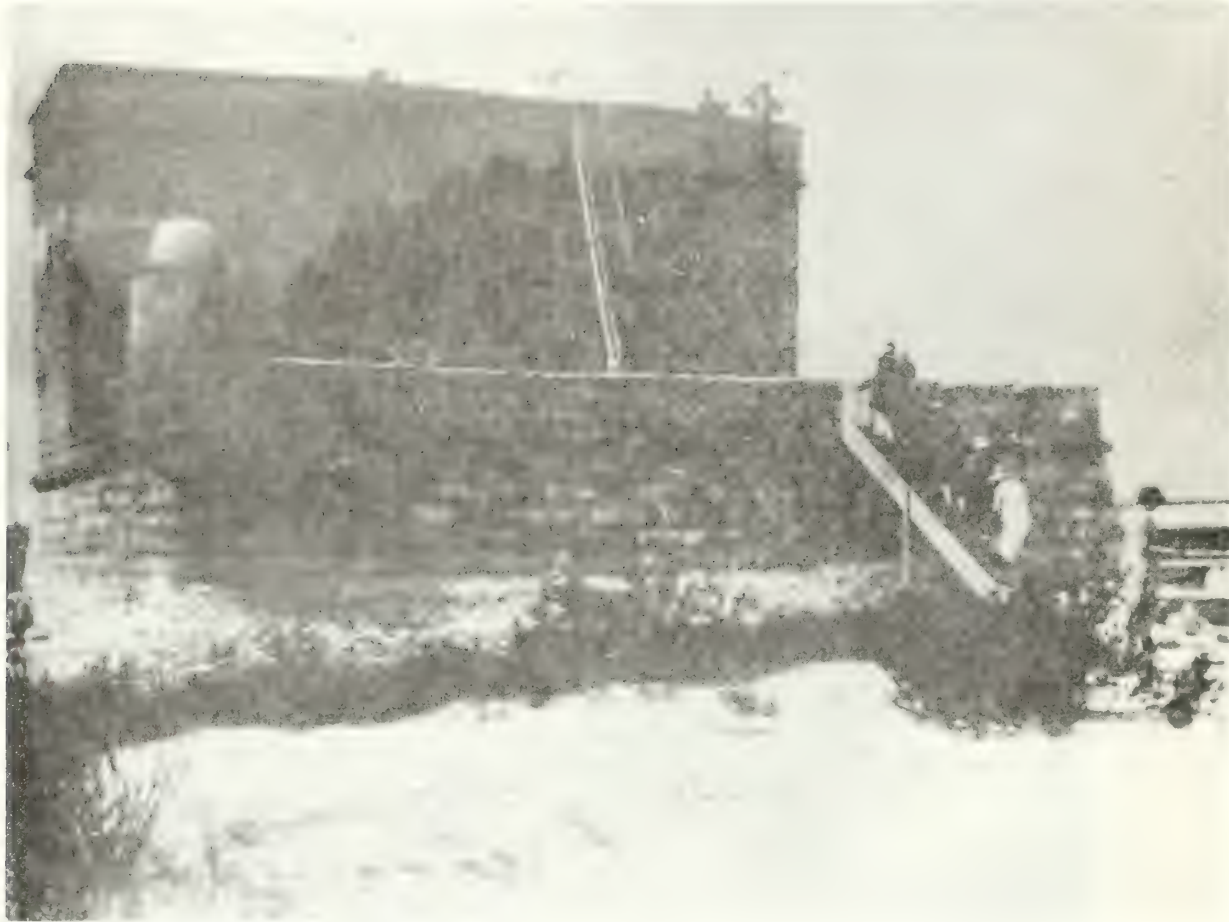
Illustration D-20

View of Fort with Oyster Shell Protection at Base and New Access Ladders, Between 1925 and 1929, (Photo M-12)

Taken about 1928, this photograph shows the Fort open to visitation after the preservation undertaken between 1916 and 1927. The ladder access visible here was supplemented by an additional ladder or stair inside going to the reconstructed concrete floor at the second level of the réduit. (See H.A.B.S. drawings, Illus. 24.)

placed around the foundation walls (Illus. D-20 and D-23). Portions of this revetment were later destroyed by either inclement weather or related construction. Additionally, the ground elevation around the fort was raised, completely covering the oyster shells. The oyster shell revetment functioned well during its time (1924-37). Eventually its purpose was superseded by later treatments.
